**URGENT: MEDICAL DEVICE CORRECTIVE ACTION-UPDATE**  
**SINGLE USE LIGATING DEVICE**

| Product Name | Model/Catalog Number | Lot Number | UDI |
|---|---|---|---|
| SINGLE USE LIGATING DEVICE POLYLOOP | HX-400U-30 | See attachment | 04953170368615 |

**Attachment 2 - SINGLE USE LIGATING DEVICE HX-400U-30**

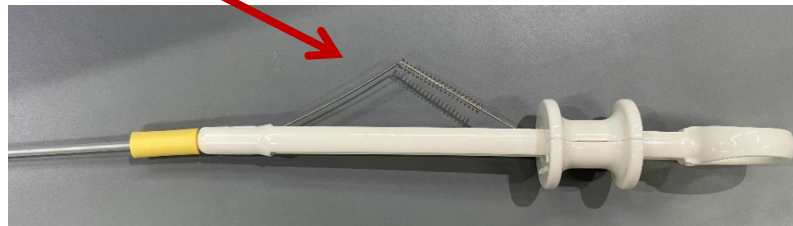
**Operation Pipe breaking**

Olympus is introducing a design change to address complaints that the ligation loop was unable to release or detach as expected during use, with operation pipe breakage being one of the contributing factors to these complaints. (see image below).

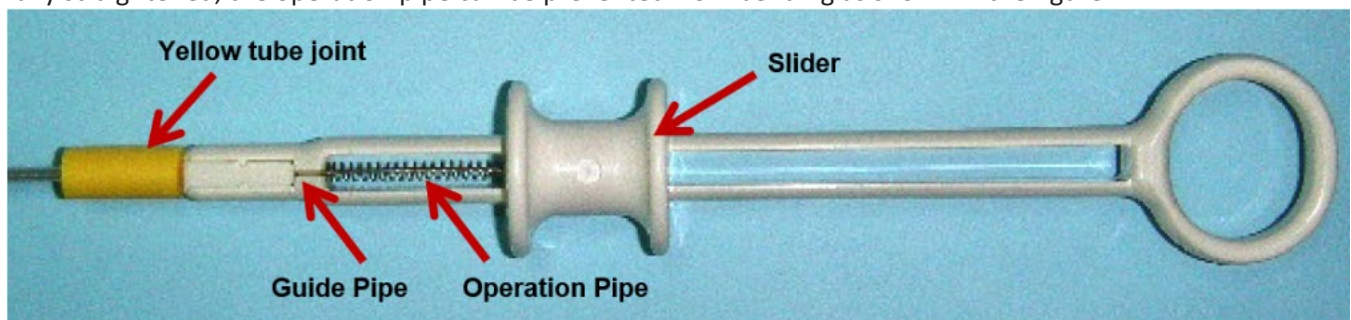
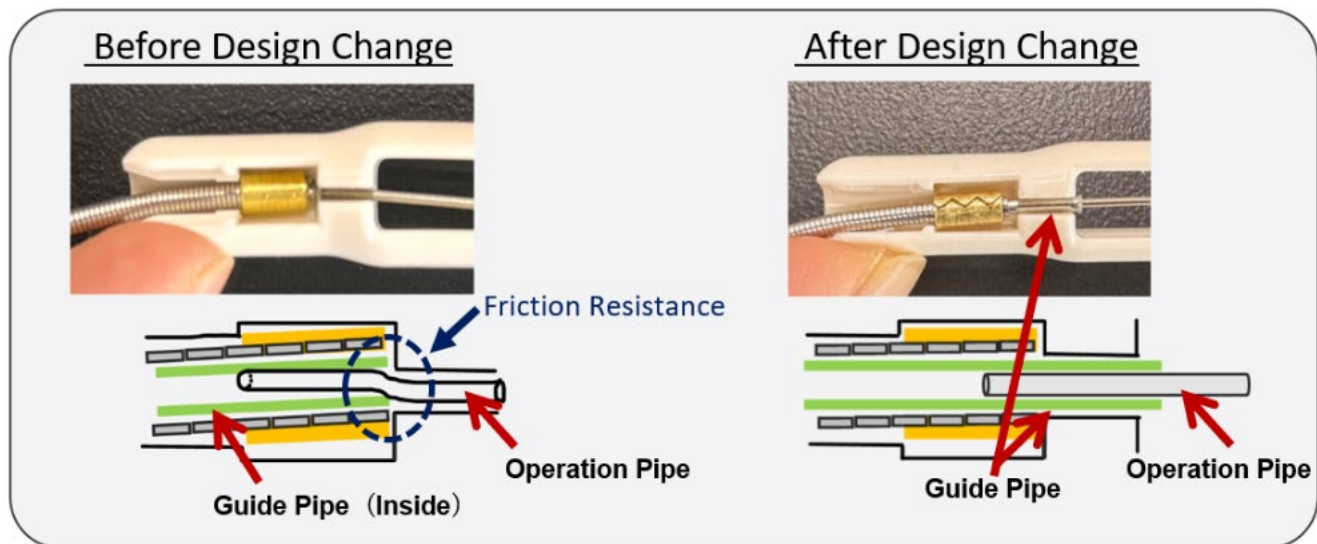
Olympus revised the method used to secure the guide pipe. As a result, even if the sheath near the handle is not fully straightened, the operation pipe can be prevented from bending as shown in the figure.

Olympus requests that customers replace older versions of the device with the new design and return them to Olympus (refer to Attachment 1). Additionally, Olympus is reminding customers to follow the updated IFU.

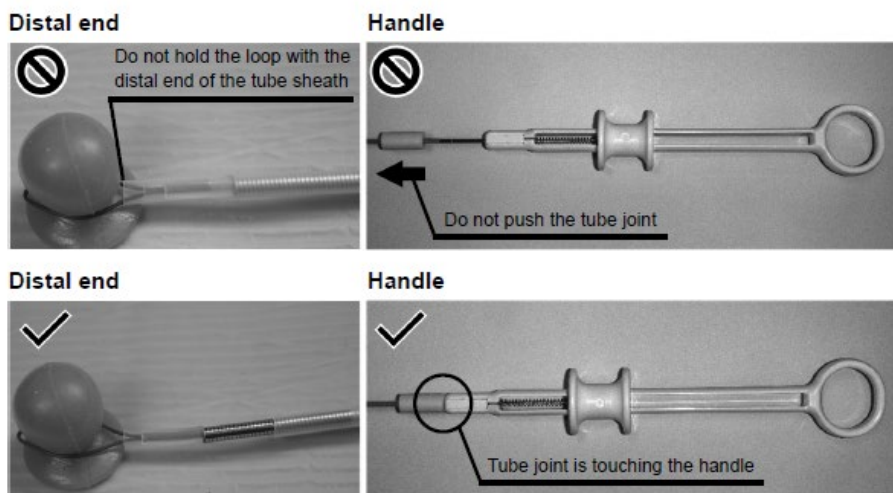
■ **Do not hold the loop with the distal end of the tube sheath while the loop is surrounding the tissue. (refer to page 5 in the manual)**

Otherwise, when the tissue is ligated, the loop may be detached from the hook in the tube sheath and tangled with the hook.

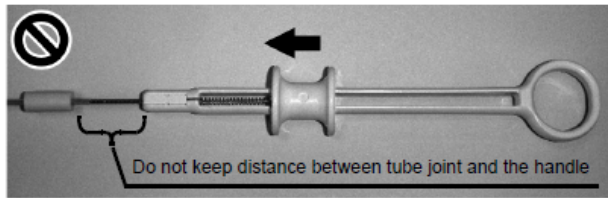
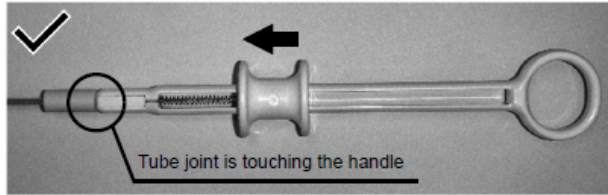
- ***Do not remove the loop from the hook while the coil sheath is not extended from the tube sheath. (refer to page 6 in the manual)***

Otherwise, the loop may be tangled with the hook and become impossible to be removed.

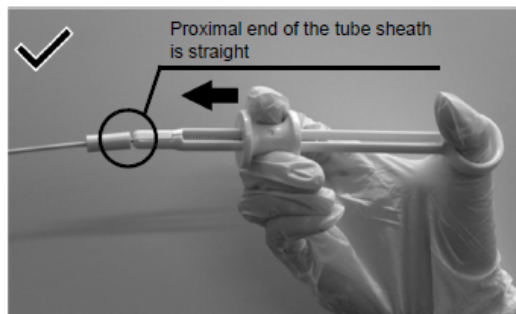
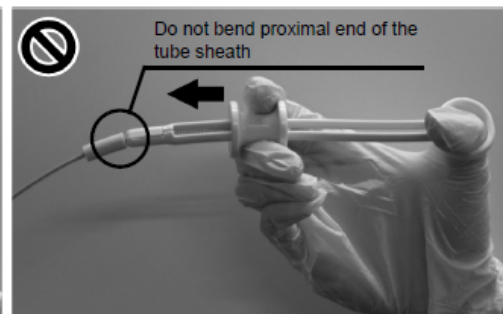
- ***With the proximal end of the tube sheath and handle kept straight against the biopsy valve of the endoscope, push the slider when detaching the loop. (refer to page 6 in the manual)***

Bending the proximal end of the tube sheath will increase frictional resistance, which may damage the handle when pushing the slider.
