Date: October 25, 2023

URGENT: MEDICAL DEVICE CORRECTIVE ACTION - UPDATE

Product: HIGH FLOW INSUFFLATION UNIT

Model: UHI-4

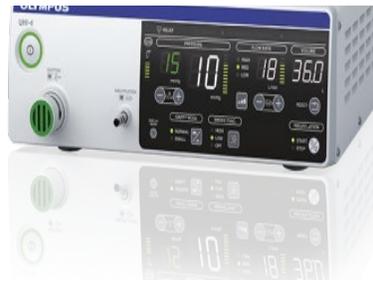
HIGH FLOW INSUFFLATION UNIT - UHI-4

Olympus has become aware of patients experiencing complications from over insufflation, including arrhythmias reported as “short cardiac arrests,” gas embolism, and one death, during surgical procedures where UHI-4s were used.

These complications may have been due to over insufflation of the abdominal cavity resulting from use of the UHI-4 during the procedures. This includes events where the device was reported to not alarm or otherwise notify the user and events where the device did not relieve the over insufflation to the set pressure. As a result, you should take the following actions:

- Olympus is notifying users to discontinue use of the UHI-4 until the root cause investigation is completed and you receive additional instructions from Olympus.
- Devices should be quarantined and marked appropriately by your site to prevent usage.
- If your facility does not have alternatives or is unable to obtain alternatives, you may choose to use the UHI-4 while exercising extreme caution, after weighing the potential benefits of the procedure versus the potential risk to health of over insufflation described below.

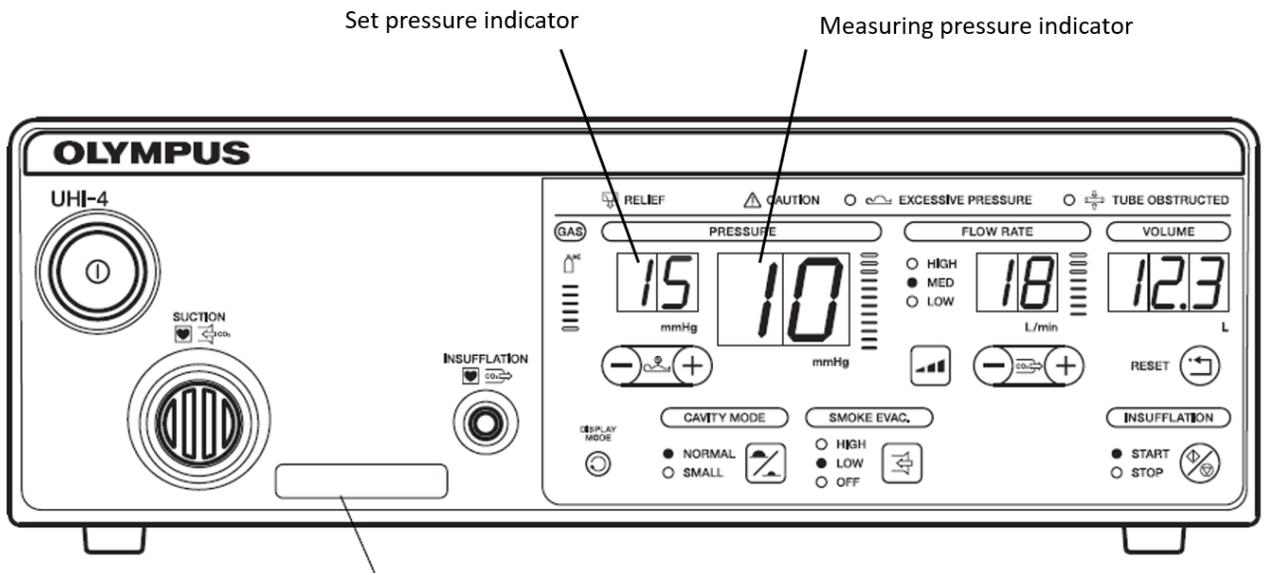
4. The instrument displays the set pressure (**set pressure indicator**) and actual pressure in the cavity (measuring pressure indicator) as indicated below. As noted on in section 5.10 of the instructions for use, when the cavity pressure exceeds the set pressure by 5 mmHg, the excessive pressure warning lamp will light and an alarm will sound.
