**URGENT: MEDICAL DEVICE CORRECTIVE ACTION-UPDATE**  
**SINGLE USE LIGATING DEVICE**

| Product Name | Model/Catalog Number | Lot Number | UDI |
|---|---|---|---|
| SINGLE USE LIGATING DEVICE POLYLOOP | HX-400U-30 | See attachment | 04953170368615 |

**Attachment 2 - SINGLE USE LIGATING DEVICE HX-400U-30**

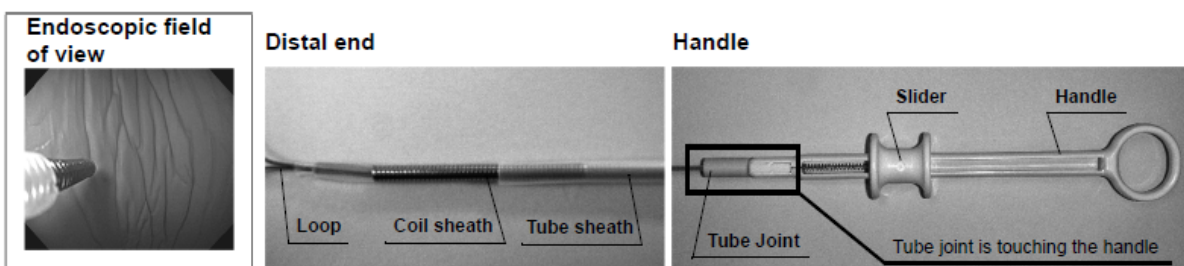
■ **Operation when ligating tissue (refer to page 6 in the manual)**

- Pull the tube joint until it touches the handle to extend the loop from the tube sheath.
- Confirm the endoscopic field of view to see that the coil sheath is extended from the distal end of the tube sheath.
